Nevada
Environmental
Restoration
Project

Post-Closure Inspection Report for
the Tonopah Test Range, Nevada

For Calendar Year 2004

U.S. Department of Energy
National Nuclear Security Administration
Nevada Site Office

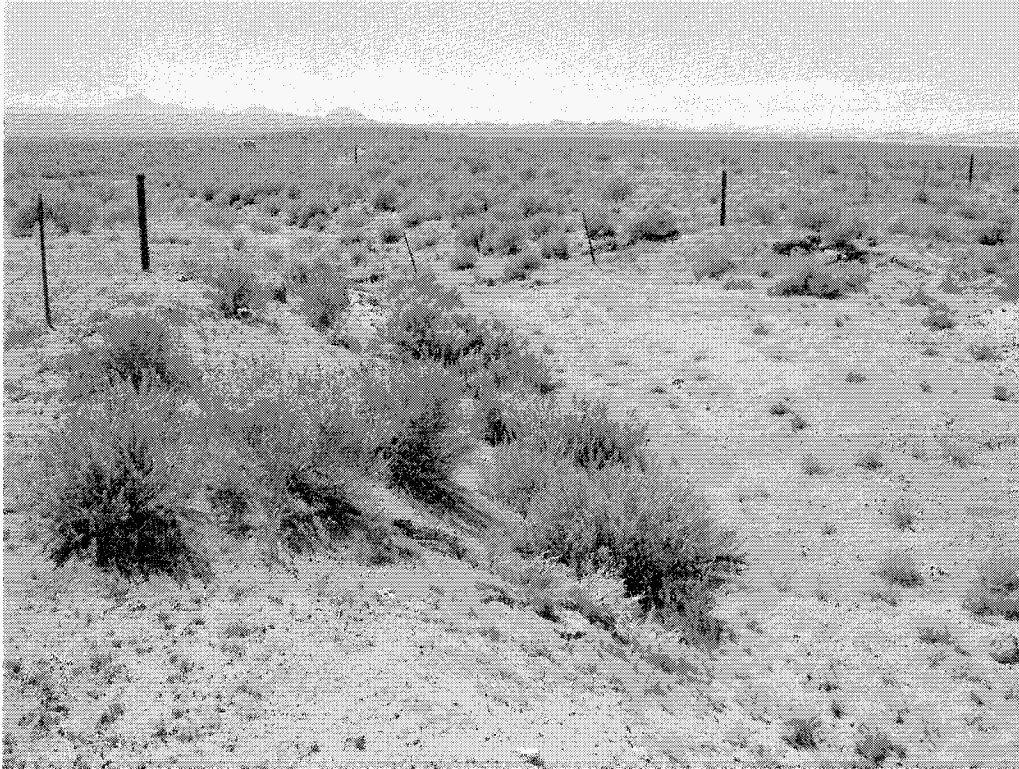
Fence damage and flood damage at the Five Points Landfill were first noticed during the July inspection. The central low-lying portion of the site was reseeded on November 16, 2004, with a seed mixture of native shrubs and grasses using a rangeland drill seeder mounted on a Kawasaki Mule towing a chain drag harrow. The reseeding activities are documented in photographs 9-12 in Appendix E. The fence was repaired during the week of November 22, 2004. To slow water flow, catch debris, and protect the fence, ten bales of straw were placed in the wash leading to the landfill and anchored using t-posts on November 30, 2004, and copies of the field notes taken during this activity are included in Appendix D.

Photograph 7: CAU 400 Five Points Landfill, fence damage, looking east, 07/07/2004

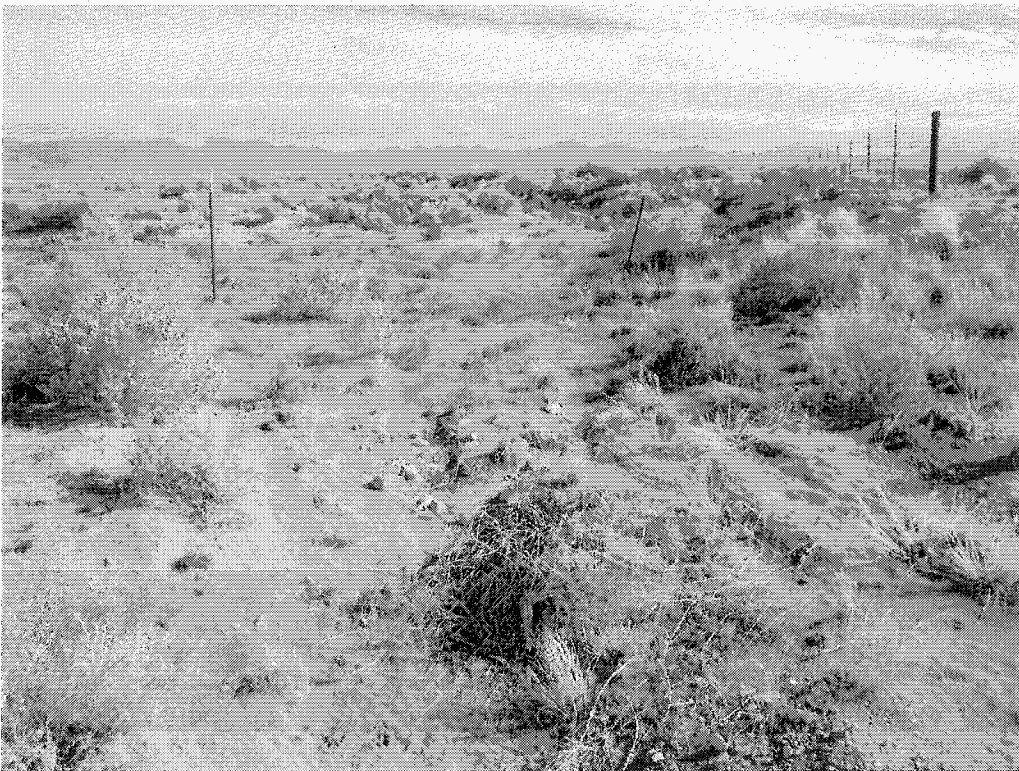
The second inspection was conducted on November 10, 2004. The previously flooded area on the central low-lying portion of the site exhibited evidence of plant mortality. Animal tracks and tire tracks from an unknown vehicle were evident leading from the washed-out portion of the fence onto the site. It was recommended to repair the fence and reseed the site.

Photograph 8: CAU 400 Five Points Landfill, fence damage, looking east, 11/10/2004

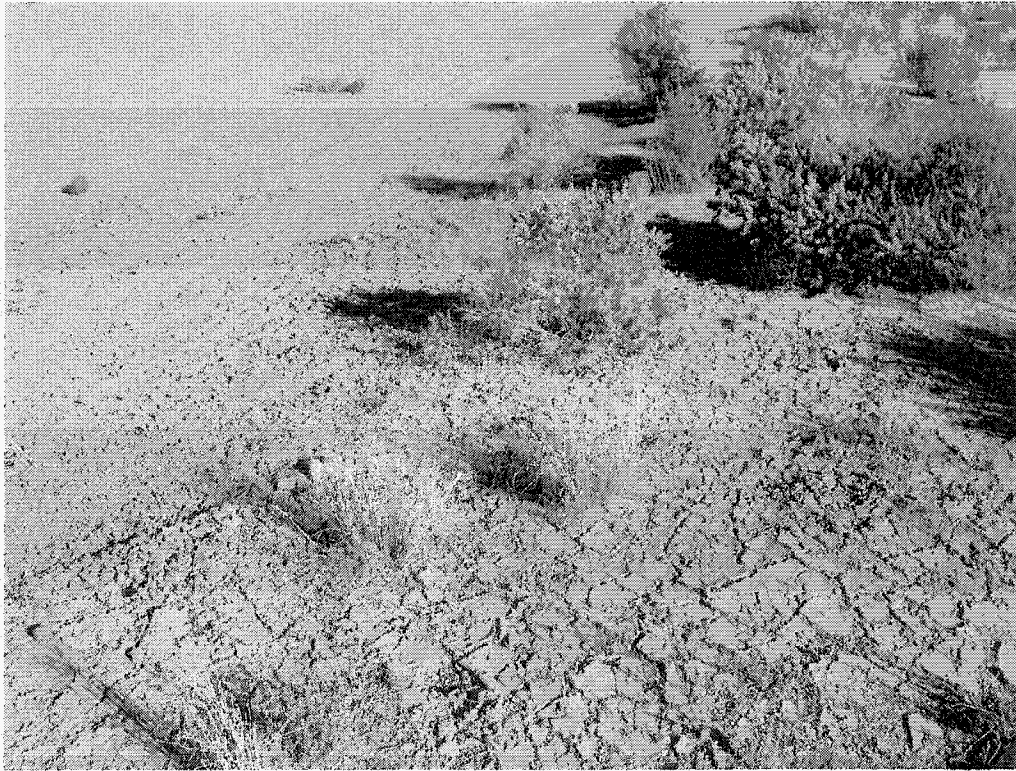
Photograph 9: CAU 400 Five Points Landfill, Reseeding, 11/16/2004

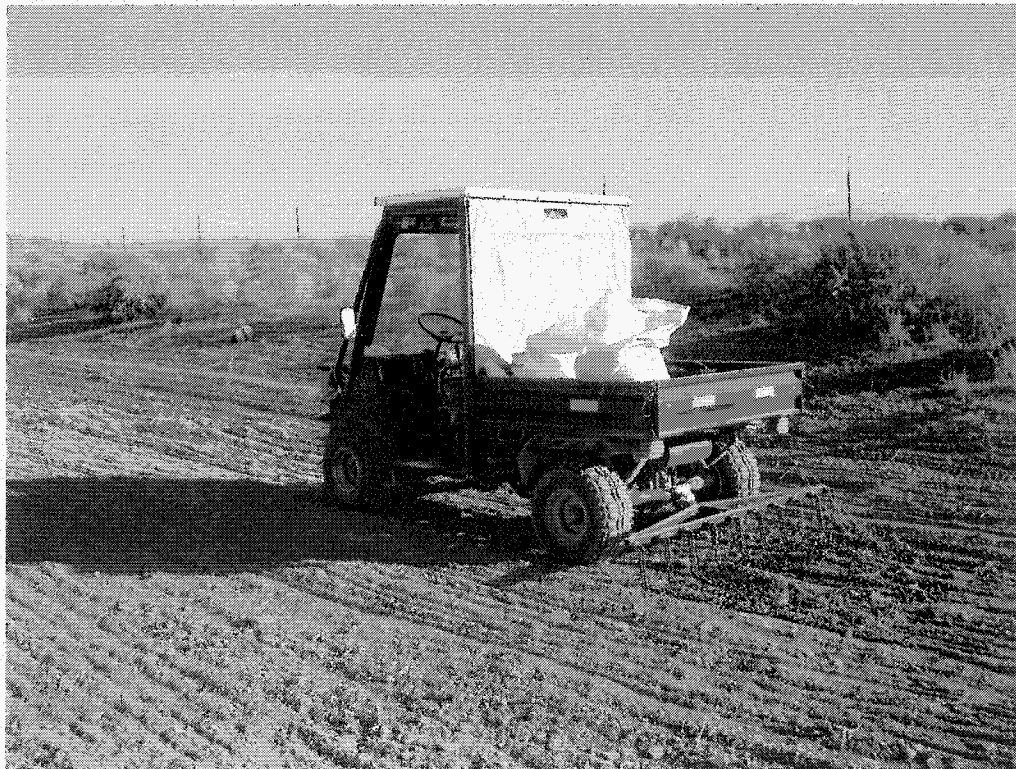
Photograph 10: CAU 400 Five Points Landfill, Reseeding, 11/16/2004

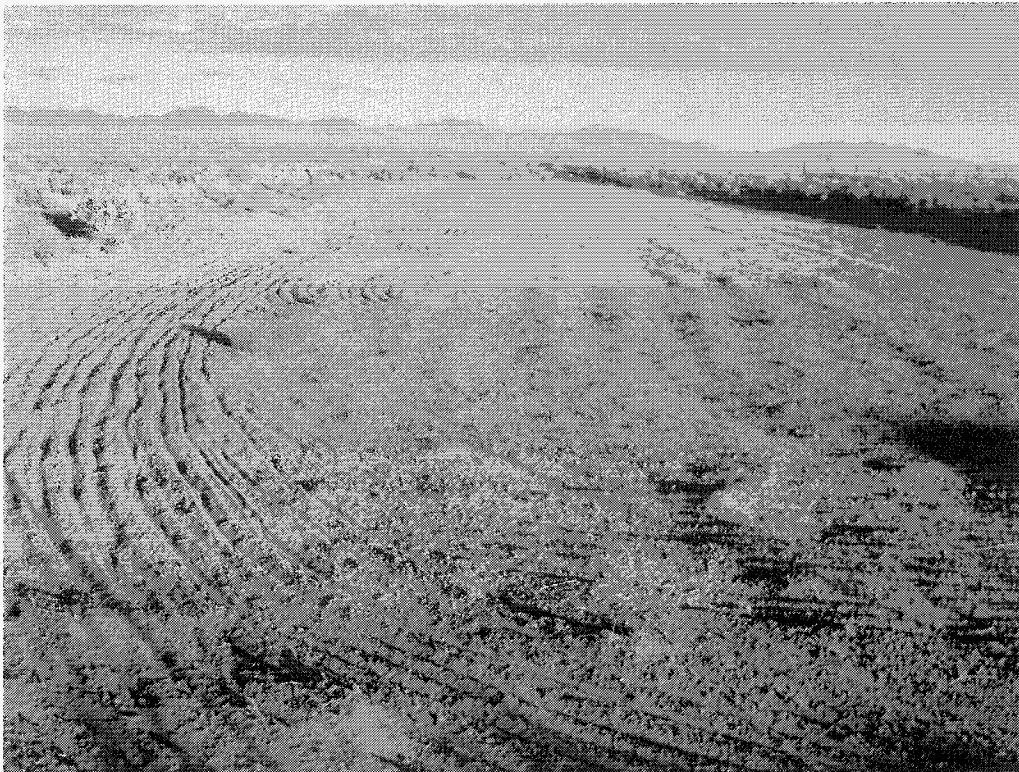
Photograph 12: CAU 400 Five Points Landfill, Reseeding, 11/16/2004

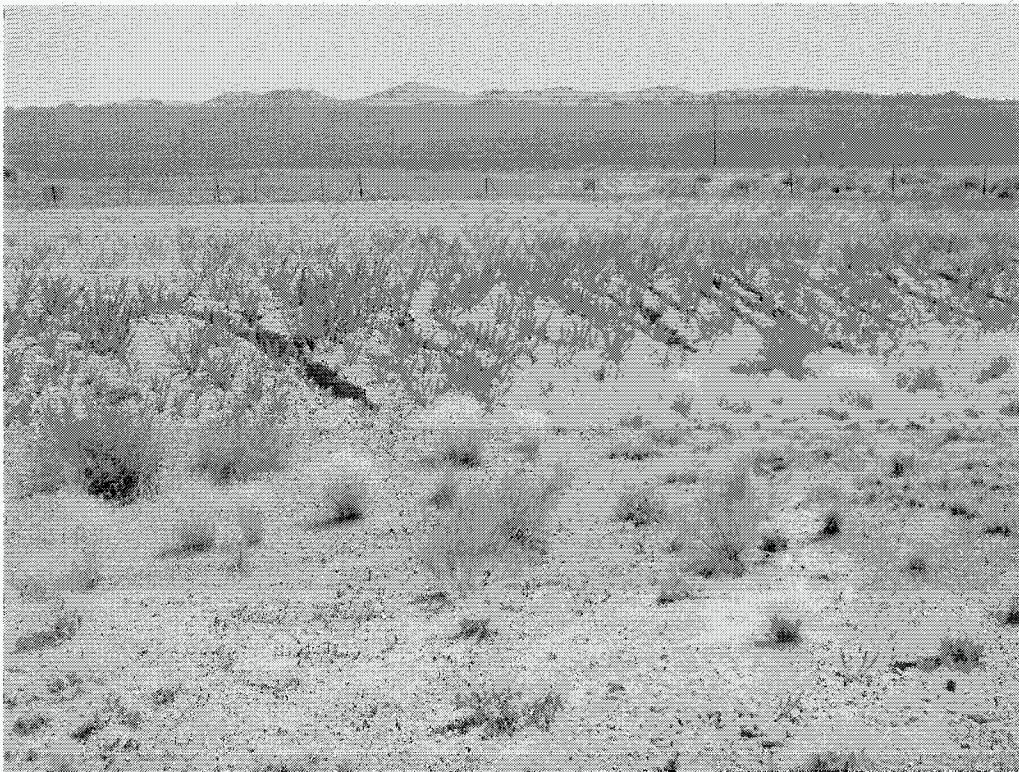
The first inspection was conducted on July 7, 2004. The inspection indicated minor but noticeable erosion rills along the cover margin that were not compromising the integrity of the cover. It was agreed that repairs would be made during the fourth quarter of Calendar Year 2004 (the first quarter of Fiscal Year 2005) when funding resources would be available. Sparse vegetation was present on the cover and had become better established since the last inspection. Some small animal burrows were also present along the edges of the cover. The fence and signs were intact and in good condition.

Photograph 17, CAU 407, Erosion rills on the east side of the cover, 07/07/2004

Maintenance and repairs at CAU 407 included erosion repair, reseeding the cover, and replacing one warning sign. One radiological warning sign was replaced by a radiological control technician on November 29, 2004. The erosion rills were filled with clean native fill on November 30, 2004. The erosion repair is documented in photographs 19 and 20 in Appendix E and in field notes in Appendix D. The cover was reseeded and mulched, and an erosion blanket was placed on December 1, 2004, to facilitate stabilization of the side slopes and mitigate the effects of storm water runoff on the soil cover. The reseeding activities are documented in photographs 21-24 in Appendix E. As recommended by the biologist, to ensure the health of the vegetation and supplement natural precipitation, the site will be irrigated in February, March, and April of 2005.

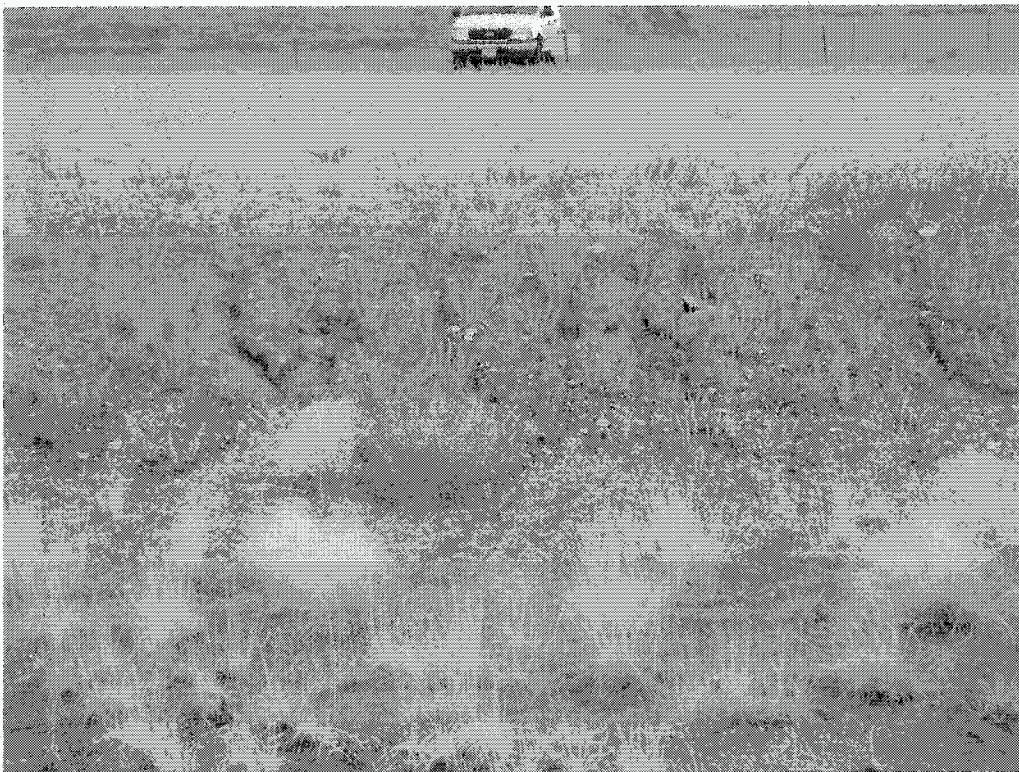
The second inspection was conducted on November 9, 2004. Erosion rills along the cover side slopes were present, with no significant change since the last inspection. Small animal burrows were observed outside the fence. The fence and signs were in good condition, with the exception of one sign with poor legibility. It was decided that the sign would be replaced during the upcoming activities to repair the erosion rills and reseed the cover before the end of 2004.

Photograph 18, CAU 407, Erosion rills on the east side of the cover, 11/09/2004

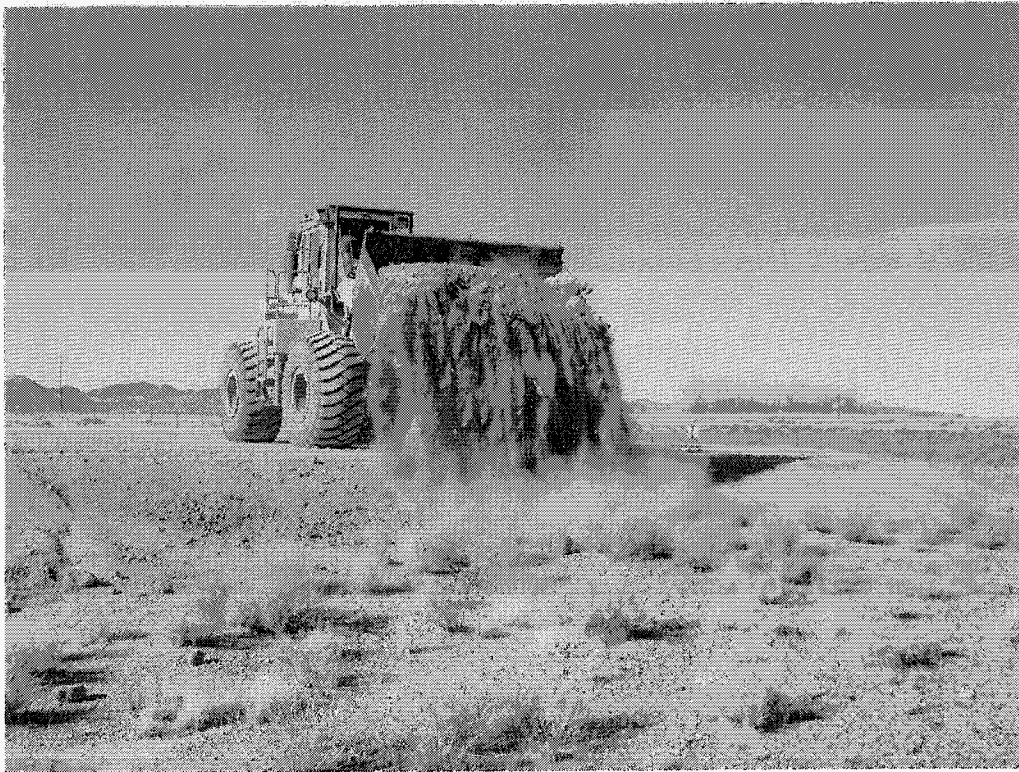
Photograph 19: CAU 407, Erosion Repair, 11/30/2004

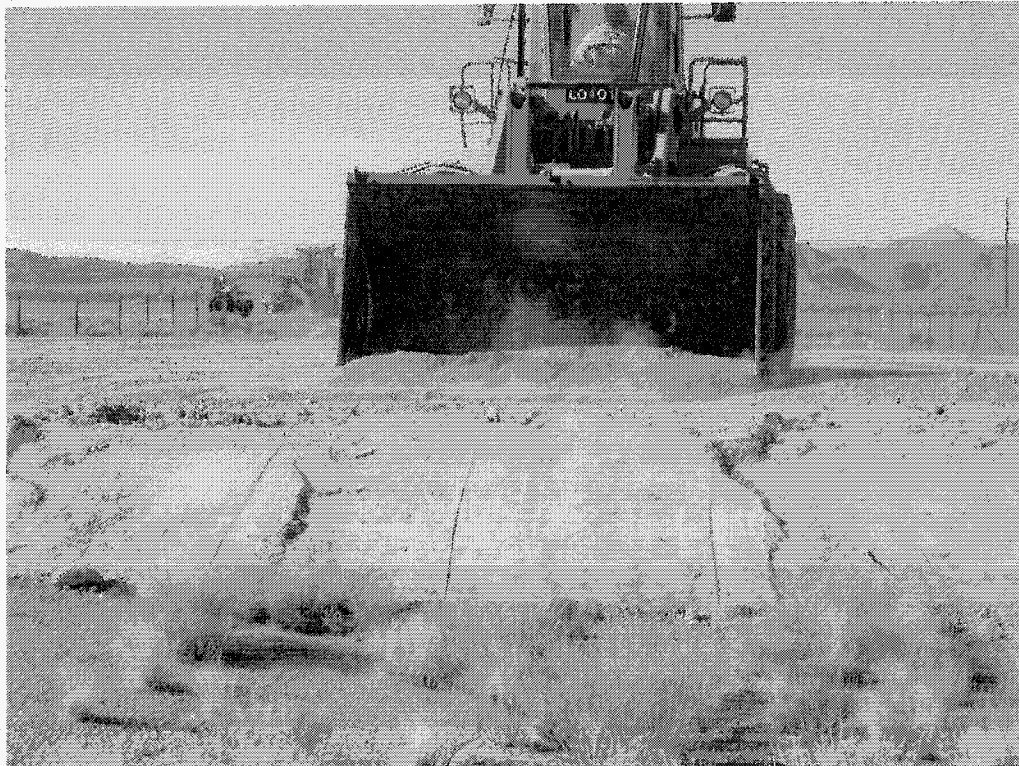
Photograph 20: CAU 407, Erosion Repair, 11/30/2004

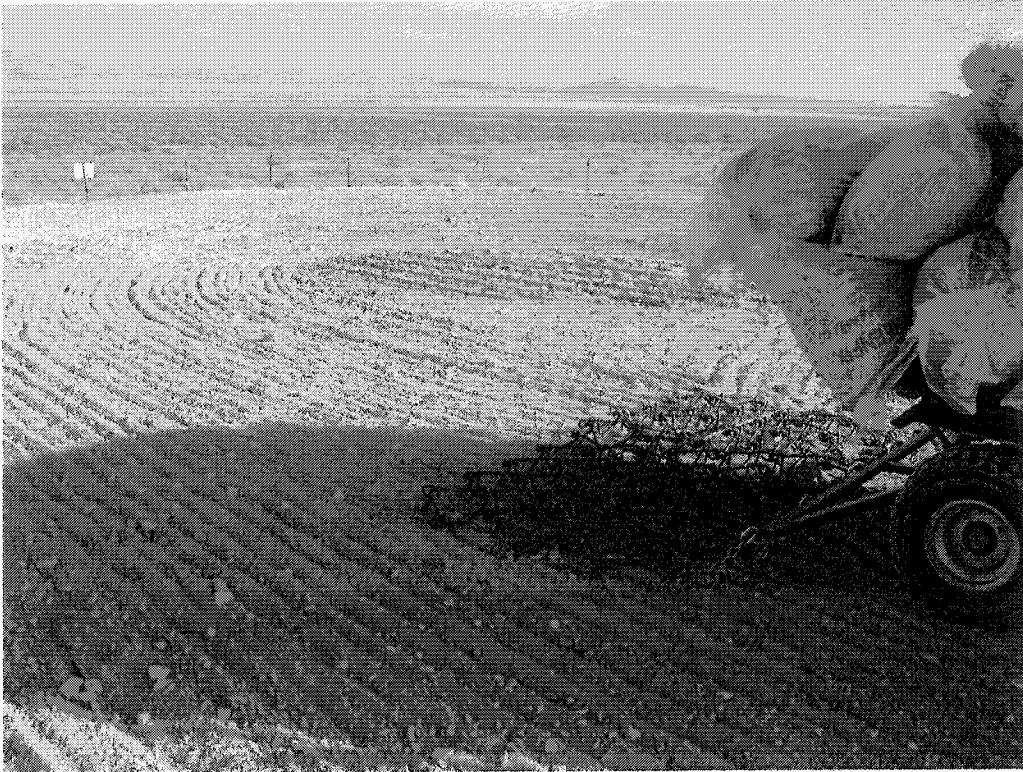
Photograph 21: CAU 407, Reseeding, 12/01/2004

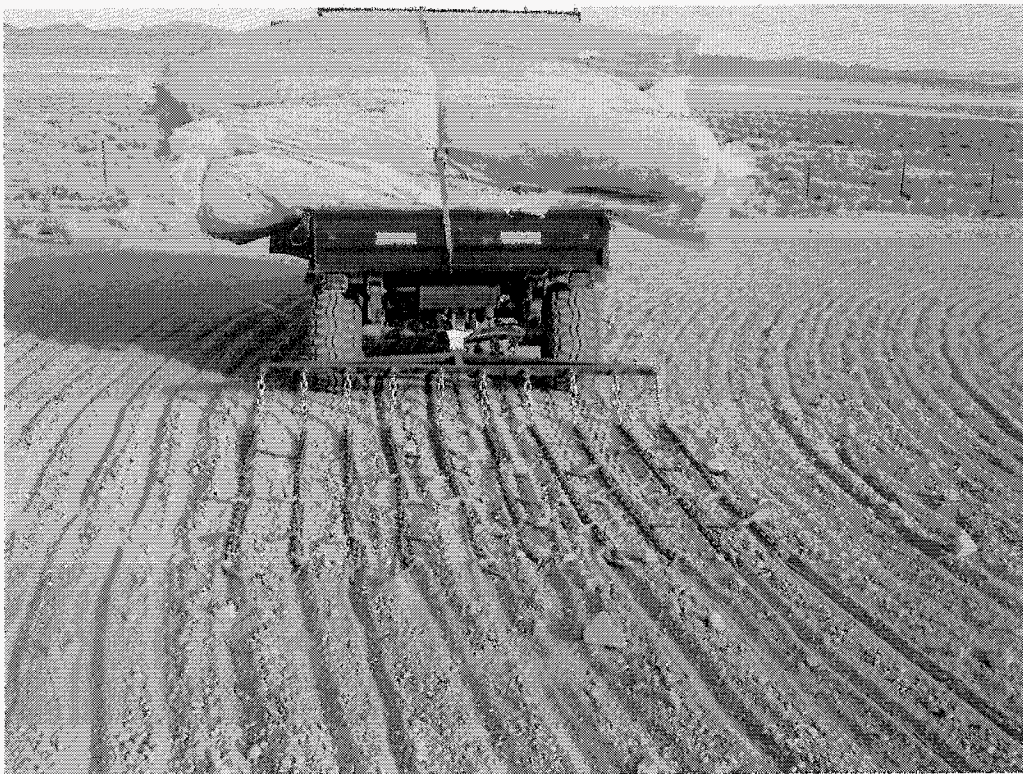
Photograph 22: CAU 407, Reseeding, 12/01/2004

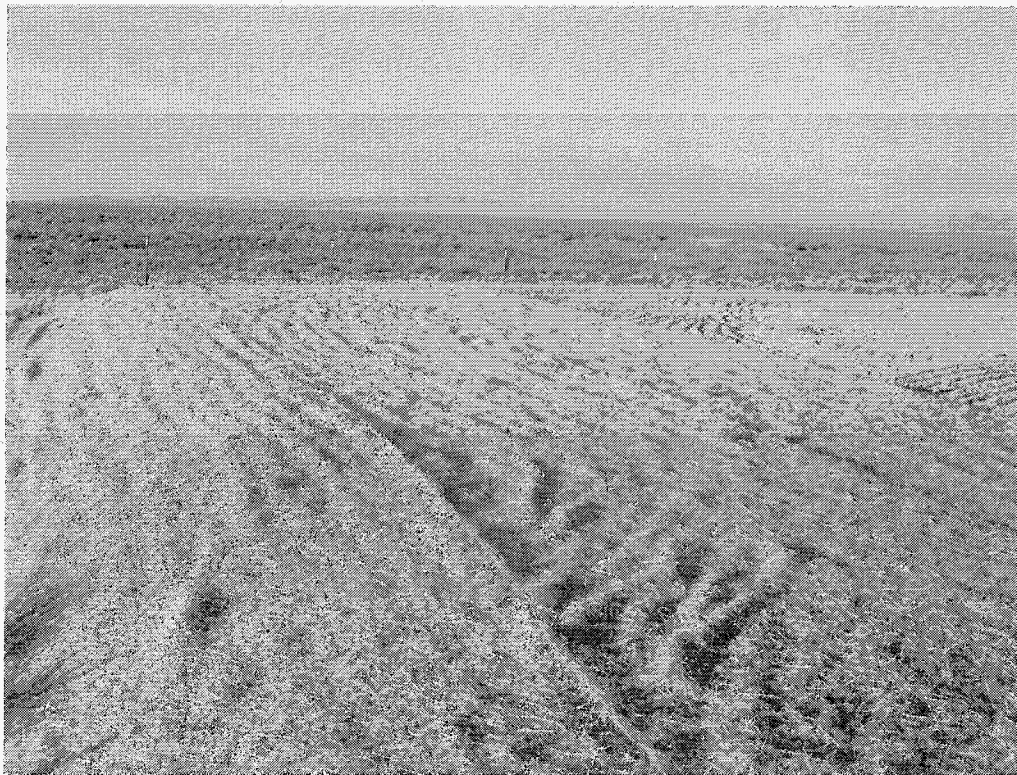
Photograph 23: CAU 407, Erosion Blanket, 12/01/2004

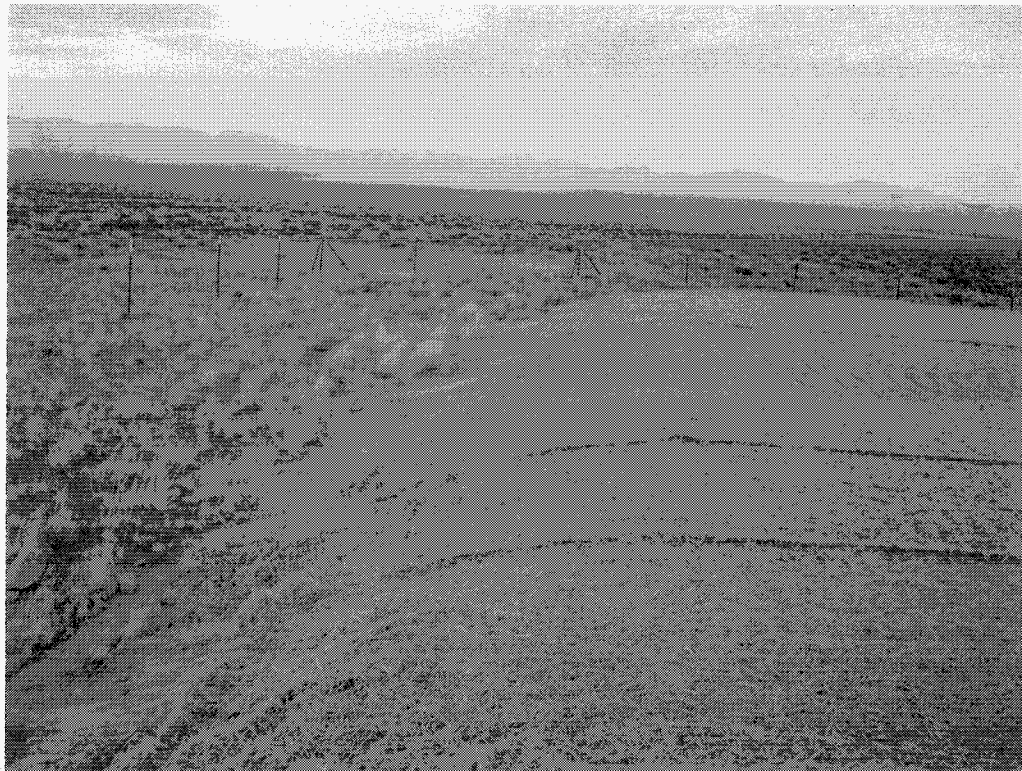
Photograph 24: CAU 407, Erosion Blanket, 12/01/2004

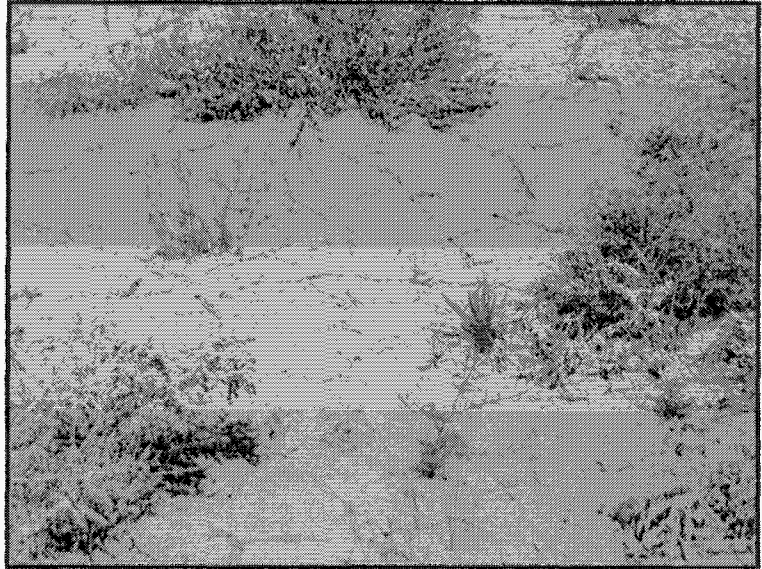
As in 2003, cover and density data were collected from non-flooded areas. The area that was under water last year is now covered with a thick layer of sediment. A few plants were found growing in the cracks (Figure 1) of the drying mud, but most of the plants that were present before the flooding are dead. There is good plant growth in the non-flooded sections, although both plant cover and plant density declined this year compared to 2003 (Table 1). Plant density decreased to 2.6 plants/m² this year, the lowest recorded since the site was vegetated in the fall of 1997. The decrease in density was mainly the result of 50 percent fewer grasses. Indian ricegrass and squirreltail were the most common grasses, but this was the first year since the spring of 2000 that galleta grass was found. The number of shrubs continues to be higher on the soil cap. Fourwing saltbush is the most common shrub. No bud sagebrush was found this year; however, some young plants of winterfat were encountered. Overall density in 2004 was slightly lower than plant density on the adjacent native plant community. This is the first year plant density on the vegetated cover was lower than on the adjacent native plant community.

Figure 1. June 3, 2004. Close-up of flash flood damage at CAU 400, Five Points Landfill. Young plants of squirreltail grass and some annual plants are growing through cracks of sediment, while plants of bud sagebrush and fourwing saltbush are covered in mud and dead.

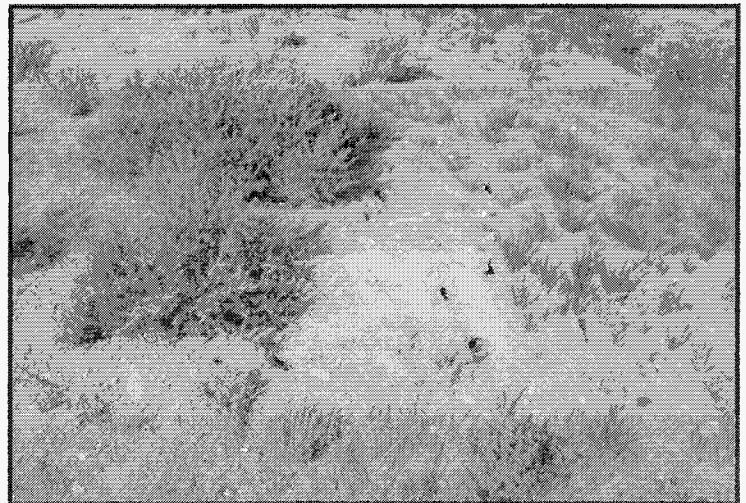
The major signs of animal use at this site are the numerous small mammal burrows on the perimeter of the soil cap (Figure 2). There are no signs of rilling or channeling on the slopes of the soil cap.

Figure 2. June 3, 2004. Small mammal burrows are frequently encountered on perimeter of the site.

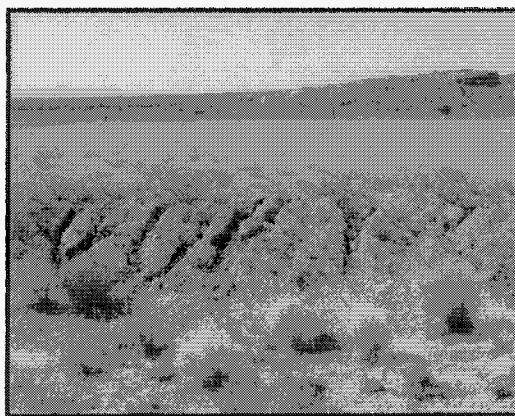
Erosion is the major concern at this site. Numerous small gullies off the slopes of the soil cap were first noted in 2003 (Figure 3). The gullies do not seem to be deeper than last year but are still present. There are also several animal burrows on the edges of the cover.

Figure 3. June 4, 2004. Erosion gullies along northern edge of the soil cap at CAU 407.

CAU 407 still lacks a vegetative cover, and erosion off the pad is severe (Figure 3). Some remedial action might be appropriate at this site. The establishment of vegetation on the cover would reduce the potential for erosion, or diversion channels could be used to direct water flow and possibly reduce the number of gullies that are forming on the cover.
